# Overview of Modifications to the CHARA Array Delay Lines

Nils Turner

29 April 2025 / CHARA Winter/Spring Meeting, Nice

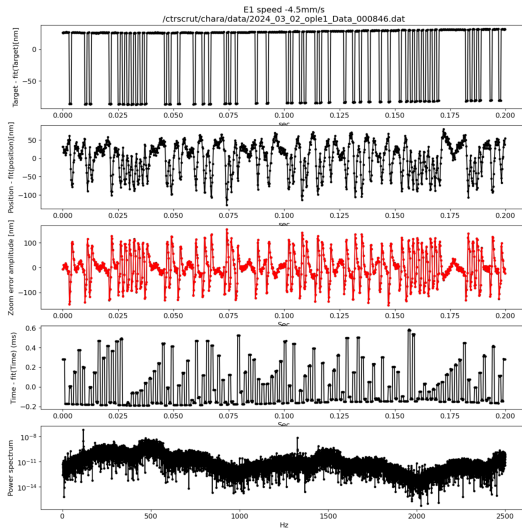
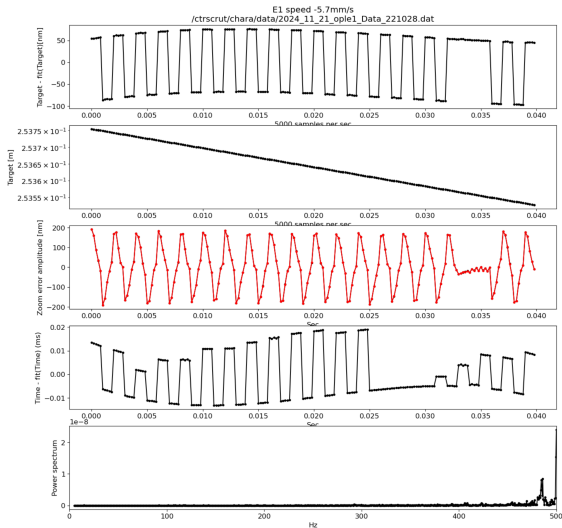
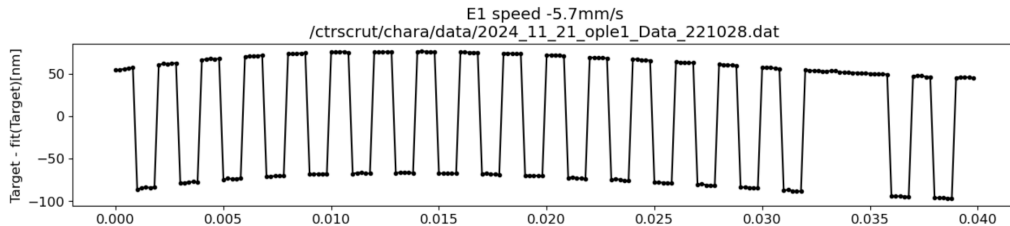
- ▶ Internal clock ticks at 40 kHz ( $25 \mu\text{sec}$  per clock cycle)
- ▶ Clock jitter is a fact of life
- ▶ Each interrupt that occurs at a 1 msec boundary is used to time tag the target data point
- ▶ The target position is interpolated between the 1 msec boundaries to match the  $200 \mu\text{sec}$  telemetry cycle
- ▶ If the clock happens to jitter more than  $25 \mu\text{sec}$  for a particular cycle, the Nios II code reads the wrong time and calculates an incorrect target position

- ▶ The legacy JPL OPLE system kept this time tag in a hardware register, effectively freezing the time tag for the full 200  $\mu$ sec cycle
- ▶ The fix was to create a variable which kept the same time tag for all calculations throughout the 200  $\mu$ sec cycle rather than asking for the clock time
- ▶ The hypothesis is that the Nios II interrupt controller doesn’t do nested interrupts correctly

- ▶ The legacy JPL OPLE system kept this time tag in a hardware register, effectively freezing the time tag for the full 200  $\mu$ sec cycle
- ▶ The fix was to create a variable which kept the same time tag for all calculations throughout the 200  $\mu$ sec cycle rather than asking for the clock time

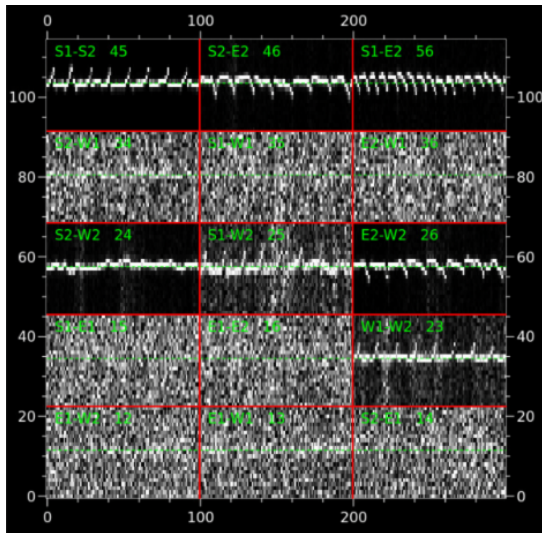
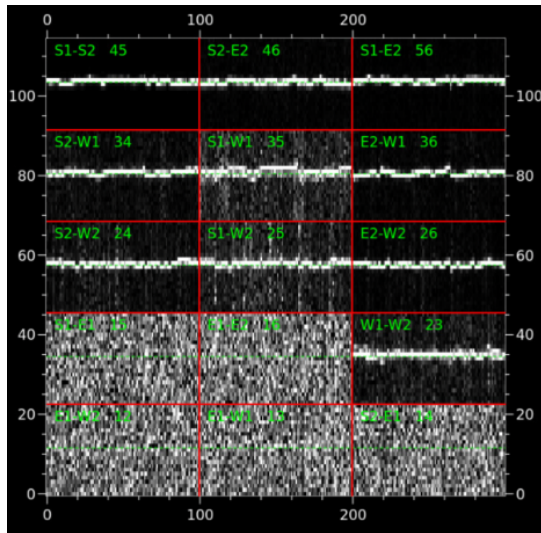
- OPLE system fails to start correctly
- OPLE cart error jumps from 20-ish nm to 400-ish nm
- Sometimes happens during the night

- OPLE system fails to start correctly
- OPLE cart error jumps from 20-ish nm to 400-ish nm
- Sometimes happens during the night
- Fix is to completely power cycle the affected delay line(s)
